St George's Church
Jesmond

Stained Glass
Preliminary Report

November 2019

Stained Glass Window Preliminary Report.

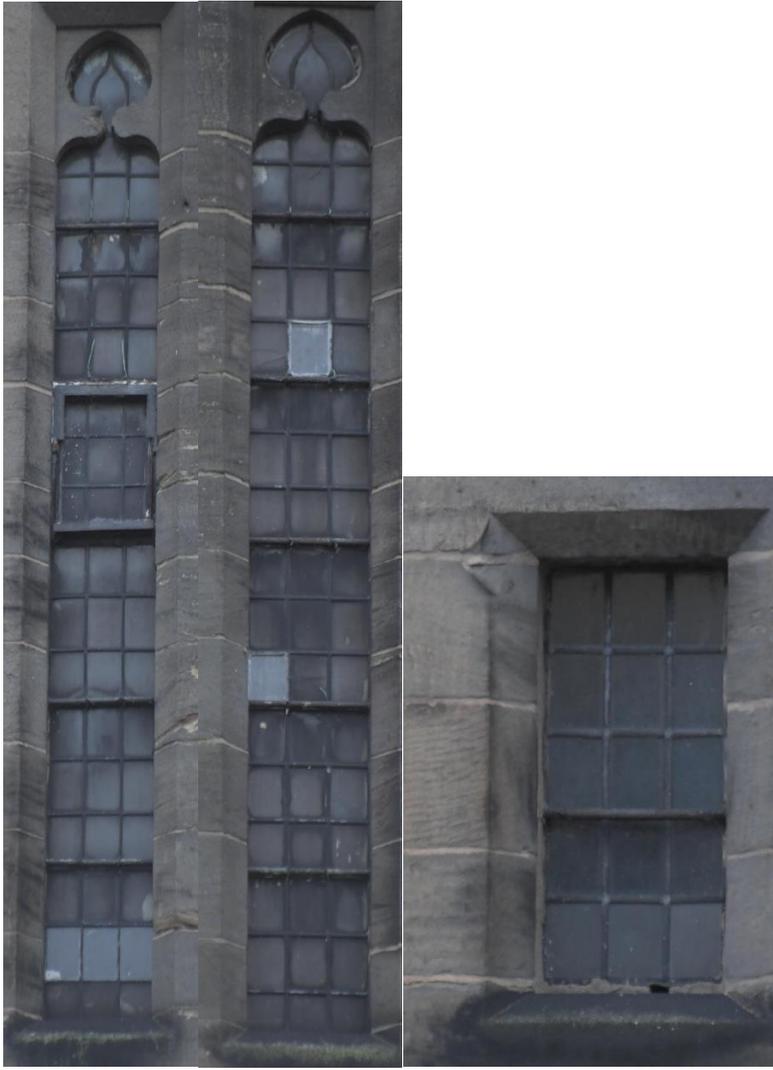
3. Inscription	none
4. Photographs	Attached
5. Condition Of glass	Many previous stop-in repairs visible. Lead badly fractured, windows leaking, gaps in pointing, ferrous vents badly corroded. Glass ingrained with soot patina. Panels buckling and ties missing. Pointed in with Portland Cement and no glazing borders.
